**Calibration of Ozone Spectrophotometers  
operating in  
Qaanaaq (Dobson #092),  
Kangerlussuaq (Brewer #053)  
and Copenhagen (Brewer #082)**

Technical Report 00-7

Author: Paul Eriksen, Middle Atmosphere Research Division

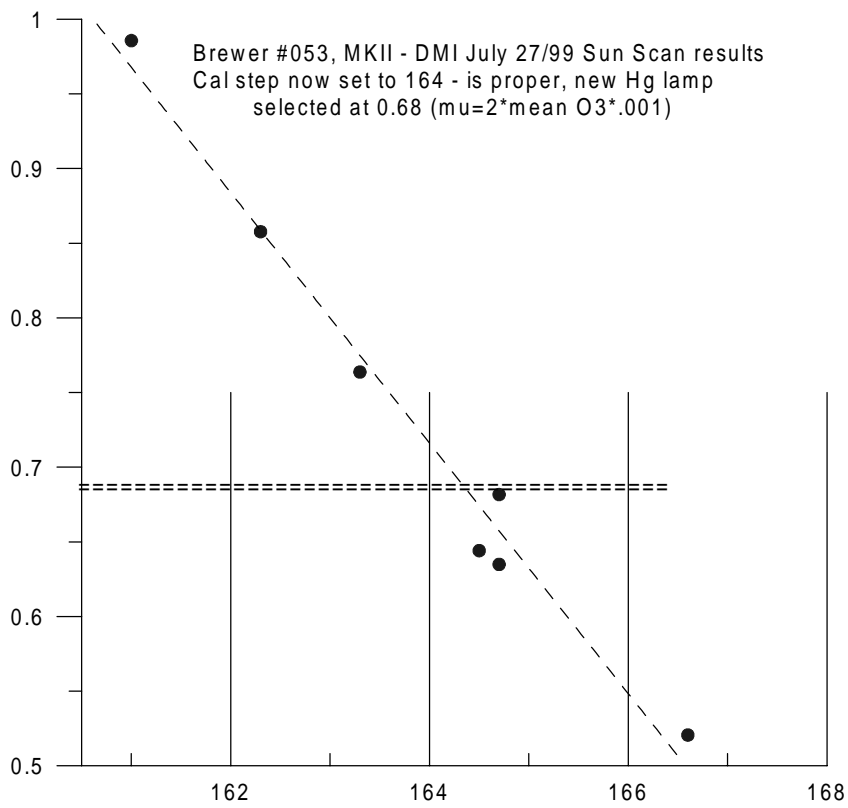
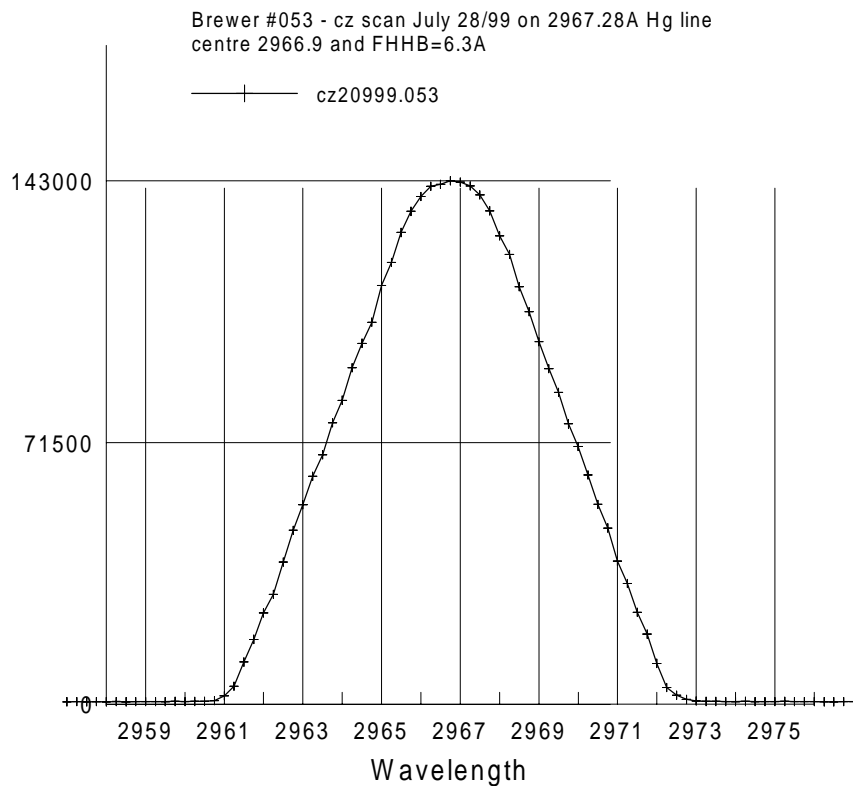
# #053 Calibration results July/1999 – Sondrestrom

The Ozone constants in use were 3038/.3165 from the 1996 calibration. The initial calibration check against traveling standard #017 resulted in ozone readings which were approximately 1% higher. There were approximately 400 good direct sun observations taken together over 3.5 clear sky days. The ETC for ozone was adjusted up 10 units as per the SL ratio change and the agreement was improved as shown below.

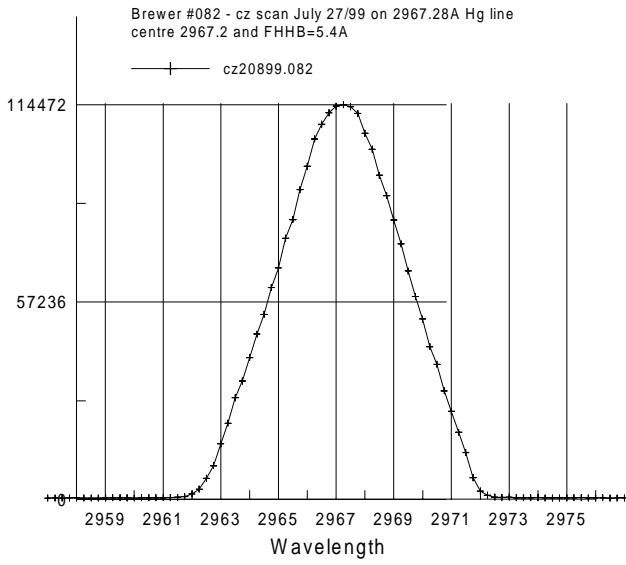
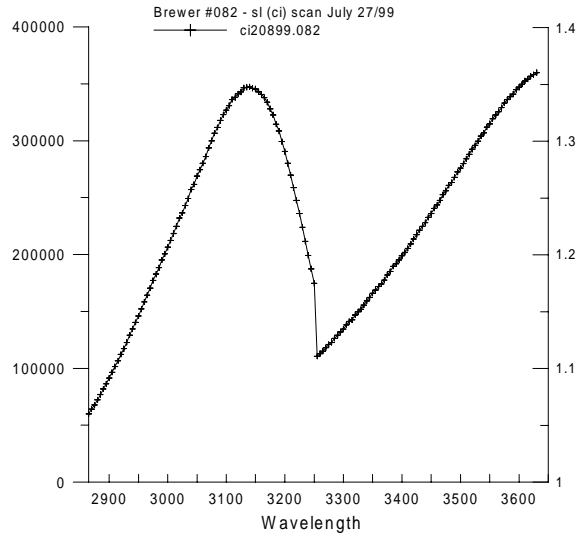
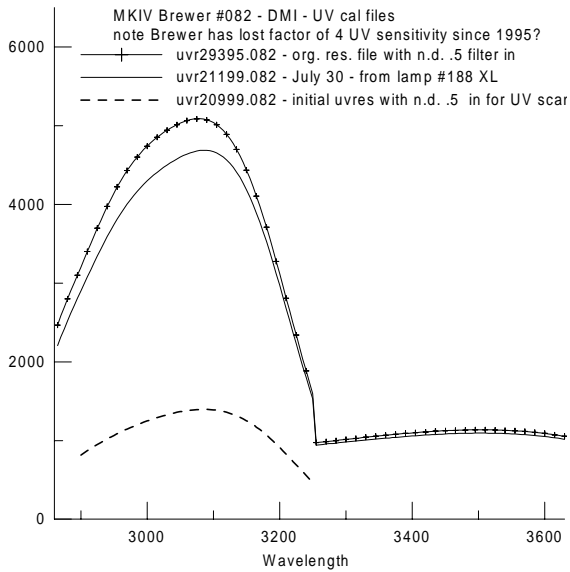
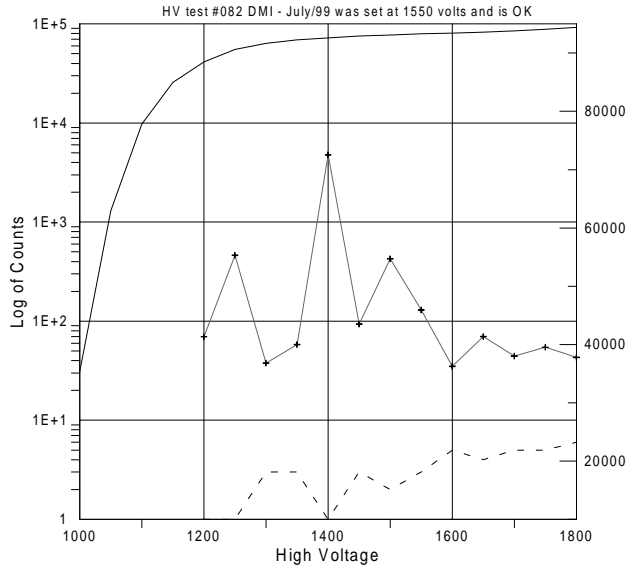
# #082 Calibration results July/1999 - Sondrestrom

The ETC constants in use were 2785/1920 from the 1995 repair/cal in Canada. The initial calibration check against traveling standard #017 resulted in ozone readings which were approximately 1% lower, however there were periods of higher deviation for a few measurements. There were approximately 300 good direct sun observations taken together over 3.5 clear sky days.

Applying the standard lamp change to ETC's plus a further SO<sub>2</sub> adjustment (to make them 2775/1850) and using the existing absn. coefficient of 0.3581/1.1912 made the agreement acceptable as shown below. Note some of the results on day 209 when cal step was off after lamp change and on last day when the PMT (it is believed) had counting errors, were removed from these daily means.

The PMT was inspected and moved in its socket about 2 mm up and down. After the DT results have been stable at 30ns but the SL ratios dropped to 1500/2715. The instrument operation has been stable and more data will be collected and compared to satellite results. The ETC constants should be adjusted to values of 2665/1635.
