**Calibration of Ozone Spectrophotometers  
operating in  
Qaanaaq (Dobson #092),  
Kangerlussuaq (Brewer #053)  
and Copenhagen (Brewer #082)**

Technical Report 00-7

Author: Paul Eriksen, Middle Atmosphere Research Division

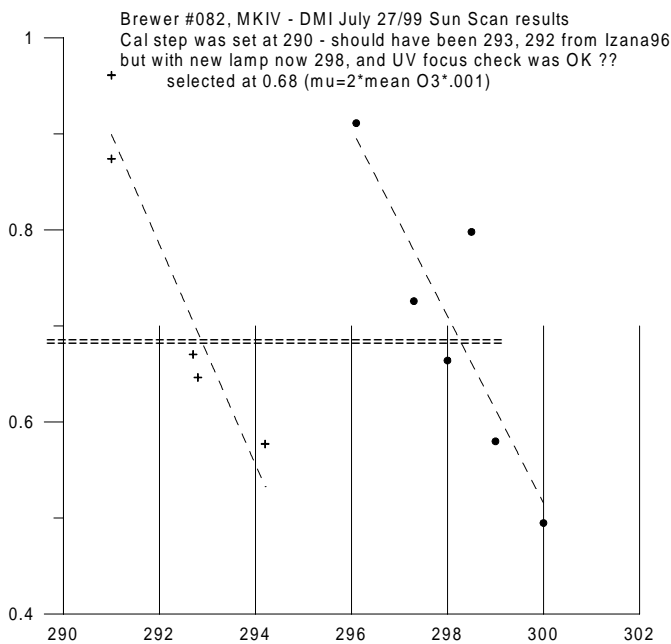
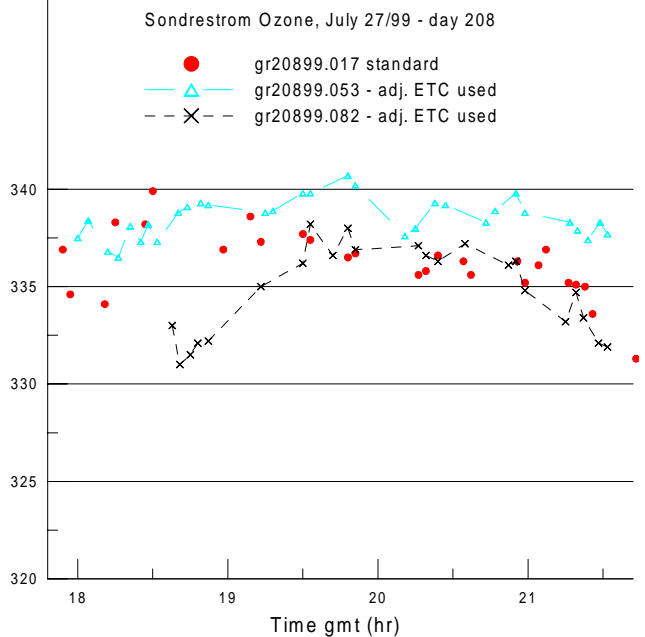
# #082 Calibration results July/1999 - Sondrestrom

The PMT was inspected and moved in its socket about 2 mm up and down. After the DT results have been stable at 30ns but the SL ratios dropped to 1500/2715. The instrument operation has been stable and more data will be collected and compared to satellite results. The ETC constants should be adjusted to values of 2665/1635.
